RENAISSANCE PLACE PARKING GARAGE 2021 PARKING FACILITY REPAIRS

PROJECT NO. RPPG 21-0603

ISSUED MAY 7, 2021

FOR BID

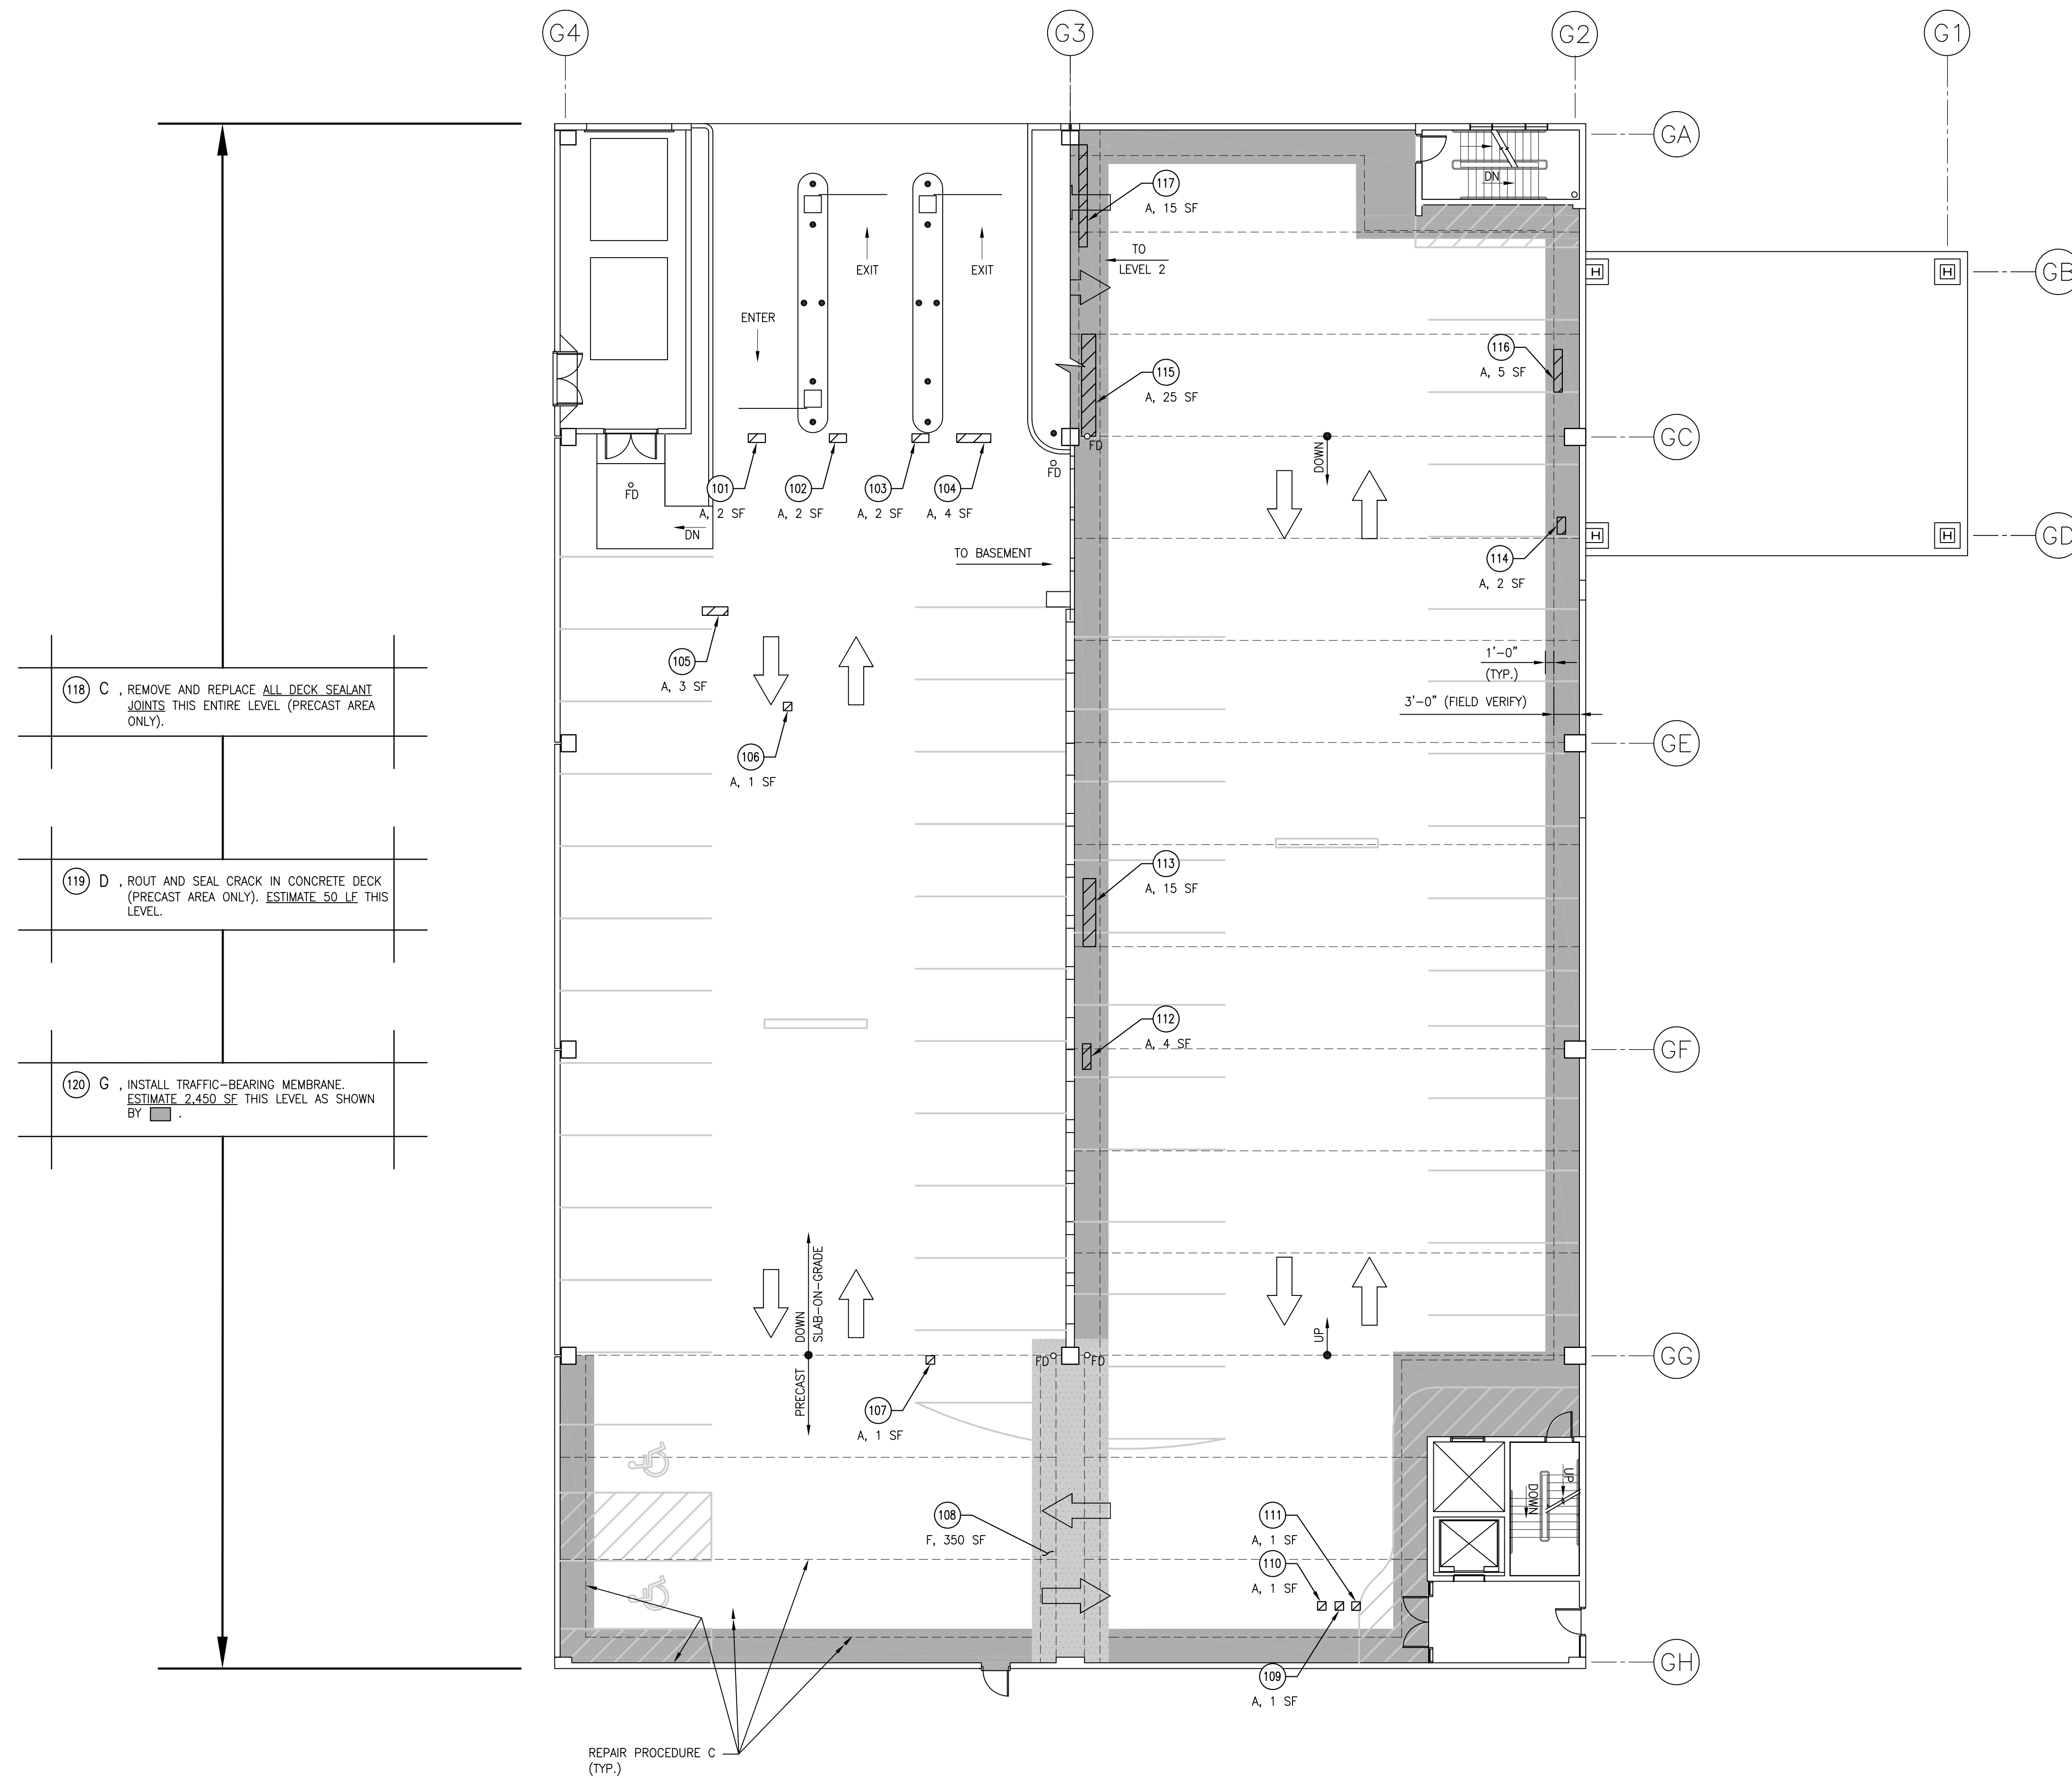
LEVEL 1 REPAIR PLAN
3/32"=1'-0" 1 R101

- 101 REPAIR PROCEDURE A, ESTIMATE 2 SF.
- 102 REPAIR PROCEDURE A, ESTIMATE 2 SF.
- 103 REPAIR PROCEDURE A, ESTIMATE 2 SF.
- 104 REPAIR PROCEDURE A, ESTIMATE 4 SF.
- 105 REPAIR PROCEDURE A, ESTIMATE 3 SF.
- 106 REPAIR PROCEDURE A, ESTIMATE 1 SF.
- 107 REPAIR PROCEDURE A, ESTIMATE 1 SF.
- 108 REPAIR PROCEDURE F, ESTIMATE 350 SF.
- 109 REPAIR PROCEDURE A, ESTIMATE 1 SF.
- 110 REPAIR PROCEDURE A, ESTIMATE 1 SF.
- 111 REPAIR PROCEDURE A, ESTIMATE 1 SF.
- 112 REPAIR PROCEDURE A, ESTIMATE 4 SF.
- 113 REPAIR PROCEDURE A, ESTIMATE 15 SF.
- 114 REPAIR PROCEDURE A, ESTIMATE 2 SF.
- 115 REPAIR PROCEDURE A, ESTIMATE 25 SF.
- 116 REPAIR PROCEDURE A, ESTIMATE 5 SF.
- 117 REPAIR PROCEDURE A, ESTIMATE 15 SF.
- 118 REPAIR PROCEDURE C, ALL DECK SEALANT JOINTS. (PRECAST AREA ONLY)
- 119 REPAIR PROCEDURE D, ESTIMATE 50 SF.
- 120 REPAIR PROCEDURE G, ESTIMATE 2,450 SF.

- 118 C, REMOVE AND REPLACE ALL DECK SEALANT JOINTS THIS ENTIRE LEVEL (PRECAST AREA ONLY).
- 119 D, ROUT AND SEAL CRACK IN CONCRETE DECK (PRECAST AREA ONLY). ESTIMATE 50 LF THIS LEVEL.
- 120 G, INSTALL TRAFFIC-BEARING MEMBRANE. ESTIMATE 2,450 SF THIS LEVEL AS SHOWN BY .

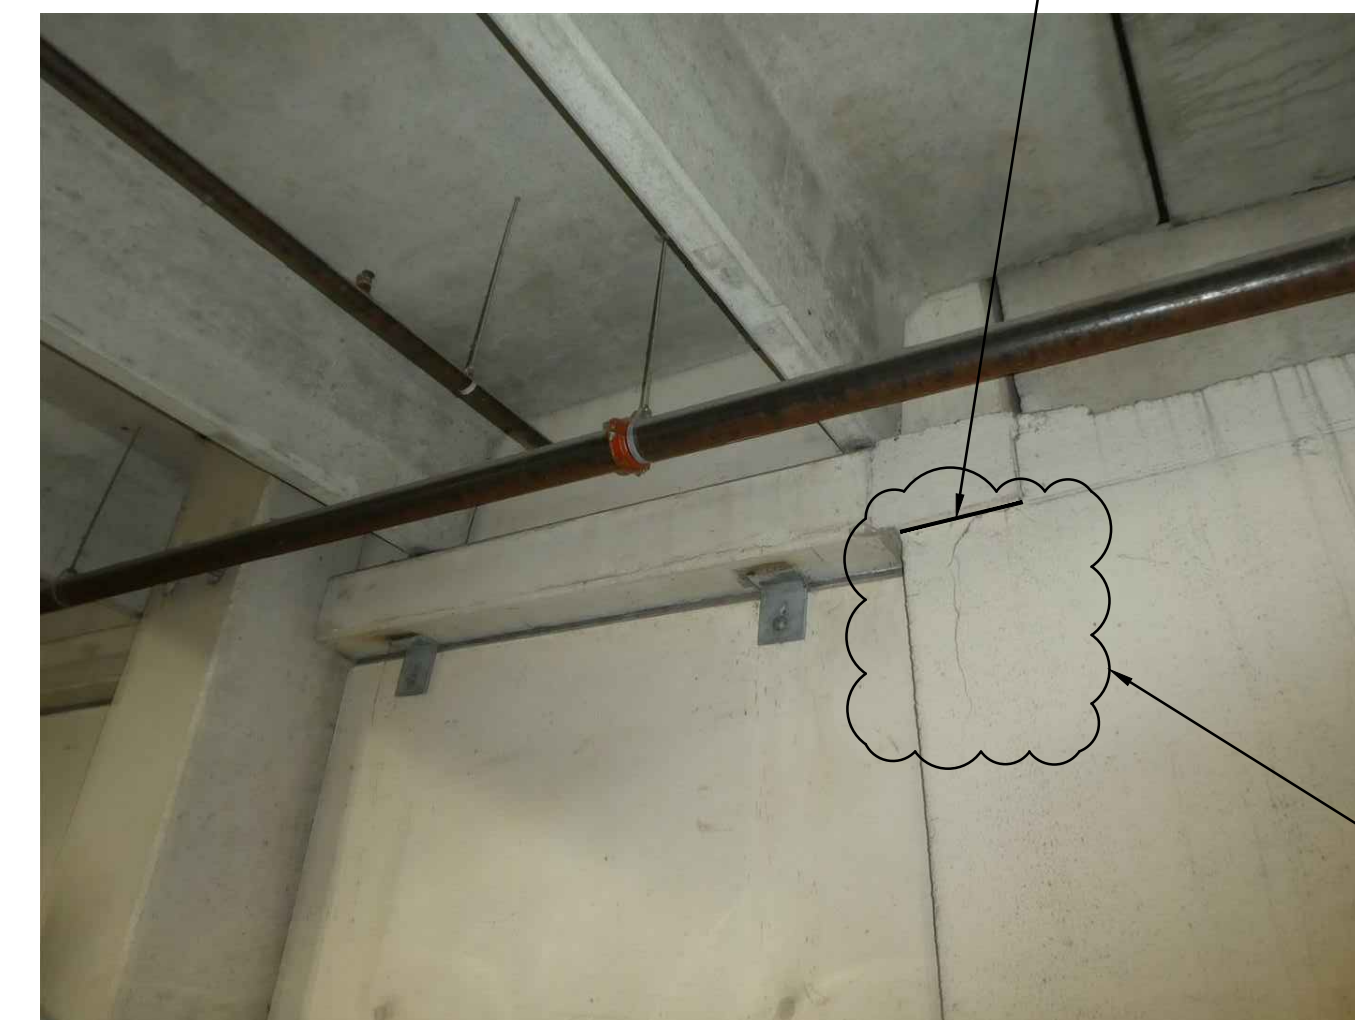
BASEMENT LEVEL PRECAST BEARING REPAIR

DURING VERTICAL CONCRETE REPAIR WORK, COORDINATE DETAILS WITH ENGINEER FOR NEW BEARING PAD. CONTRACTOR TO PROVIDE AND INSTALL NEW FABREEKA-PTFE BEARING PAD BELOW PRECAST SPANDREL WALL PANEL. FIELD VERIFY DIMENSIONS. PROVIDE SHORING AS NECESSARY TO SUPPORT END OF PANEL DURING REPAIR WORK.

REPAIR PROCEDURES B & E

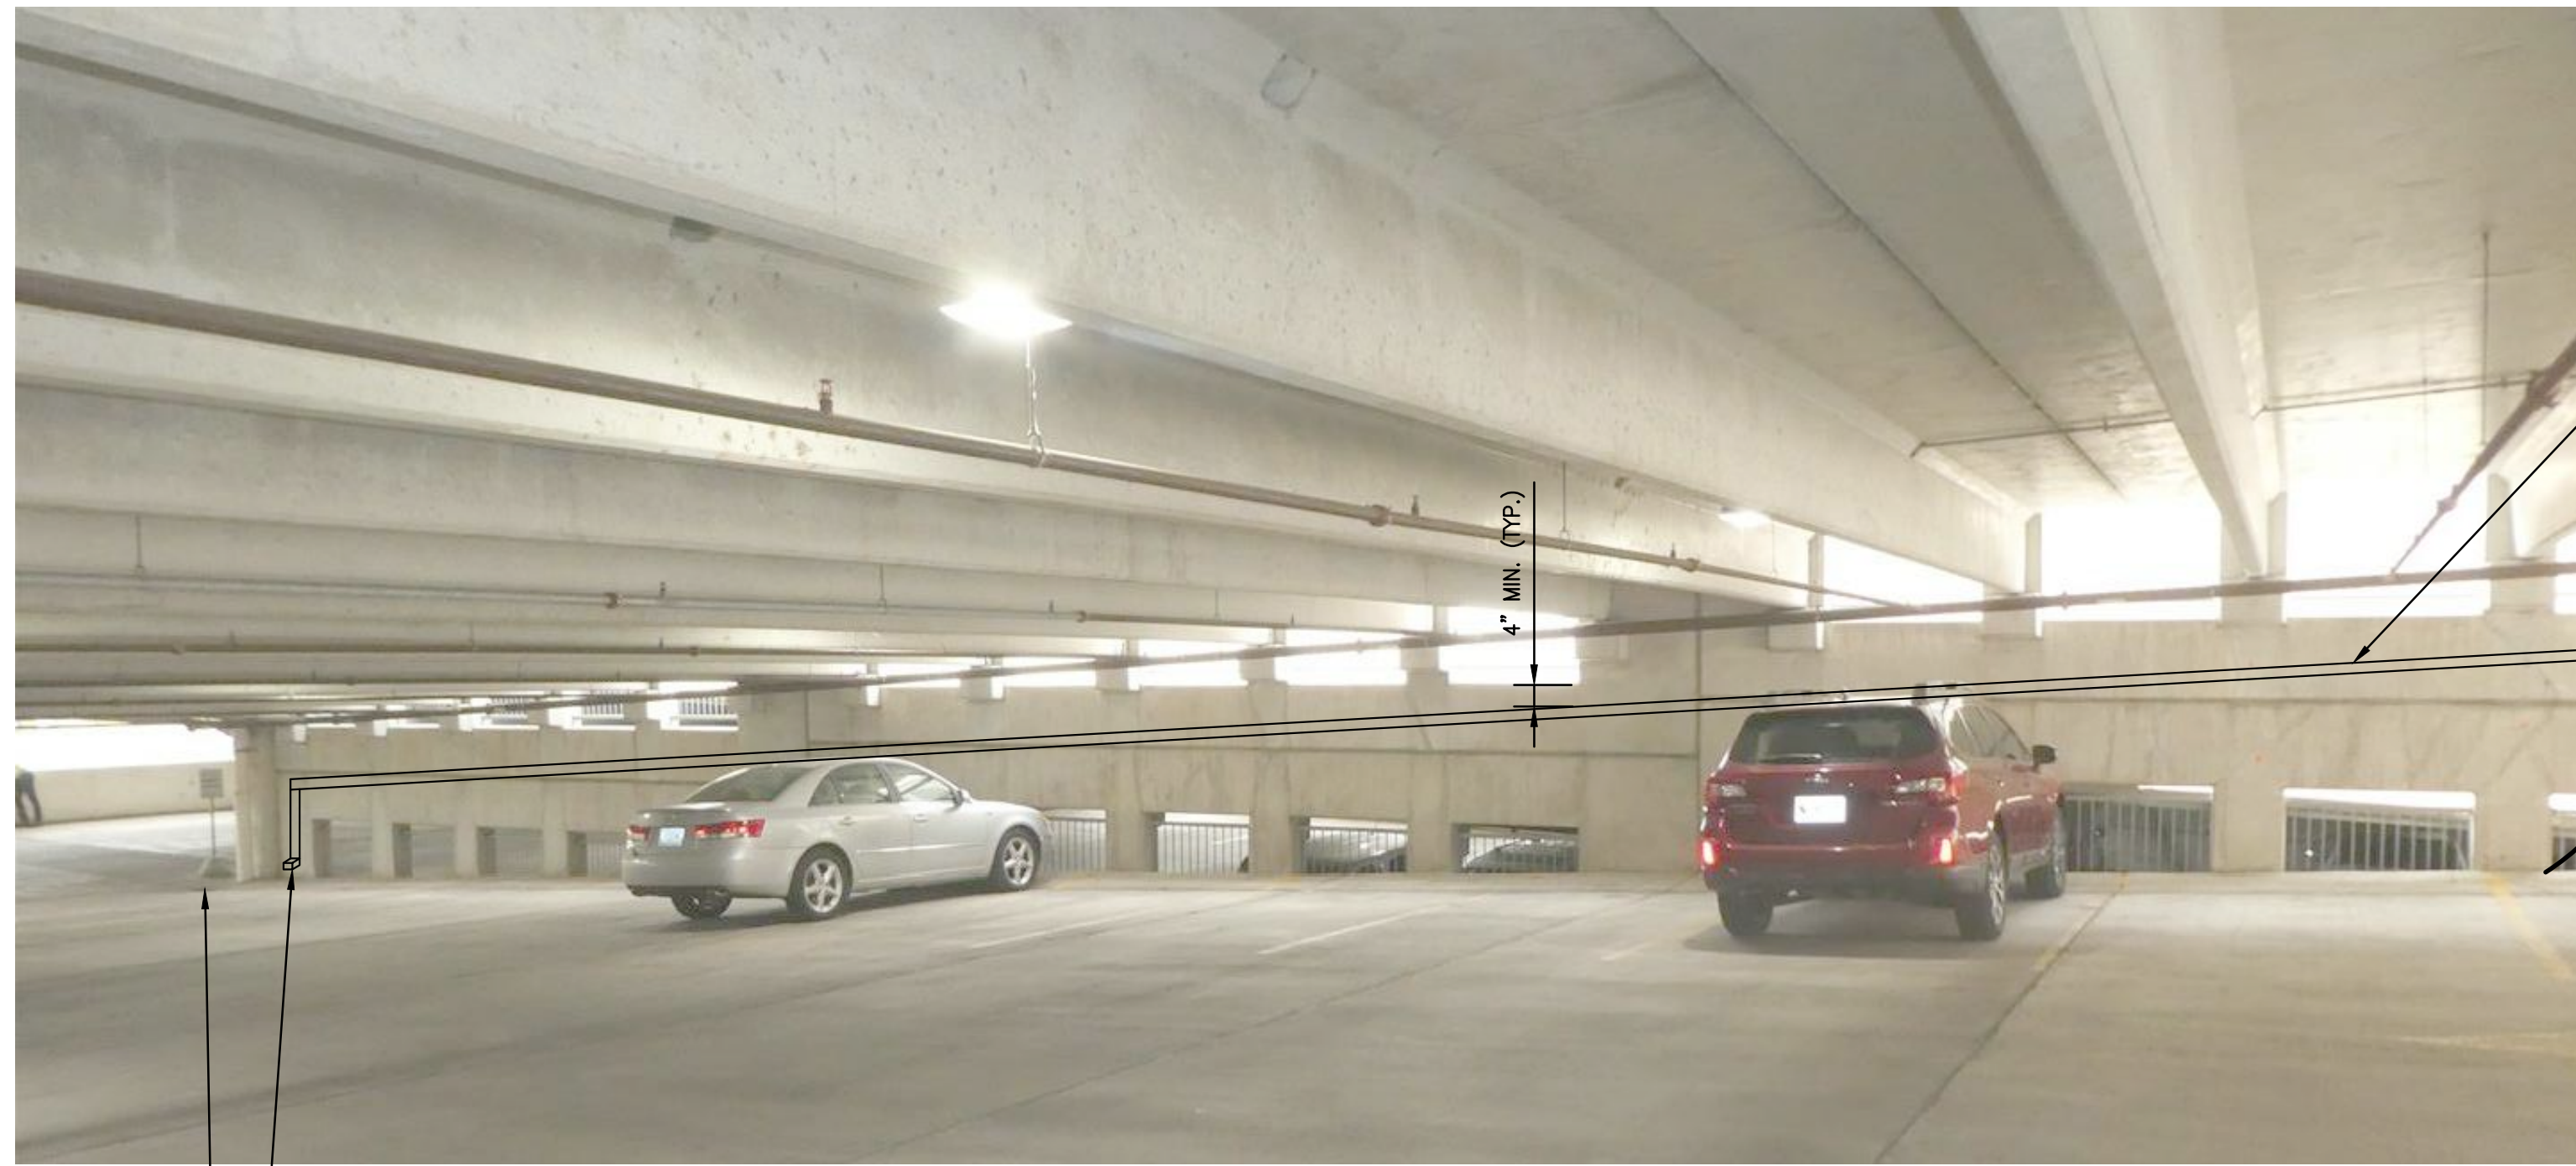
LEVEL 4 RAMP WALL 1
NTS R501

18 GA. TYPE 304 STAINLESS STEEL CONTINUOUS BOX GUTTER SYSTEM. FIELD VERIFY LENGTH AND SLOPE TO MAINTAIN MIN. CONTINUOUS CLEARANCE OF 4" BELOW THE BOTTOM OF THE EXIST. RAMP WALL OPENINGS. SEE SPECIFICATIONS FOR ADDITIONAL SHEET METAL REQUIREMENTS.

EXIST. FLOOR DRAIN — STAINLESS STEEL TYPE 304 DOWNSPOUT WITH 12" EXTENSION ANGLED TOWARDS TOP OF CONCRETE DECK IN DIRECTION OF ADJACENT FLOOR DRAIN. FASTEN DOWNSPOUT WITH STAINLESS STEEL BRACKETS AND CONC. SCREWS TOP AND BOTTOM.
